STEAM SHOWERS 101

Torino Tile to the Rescue

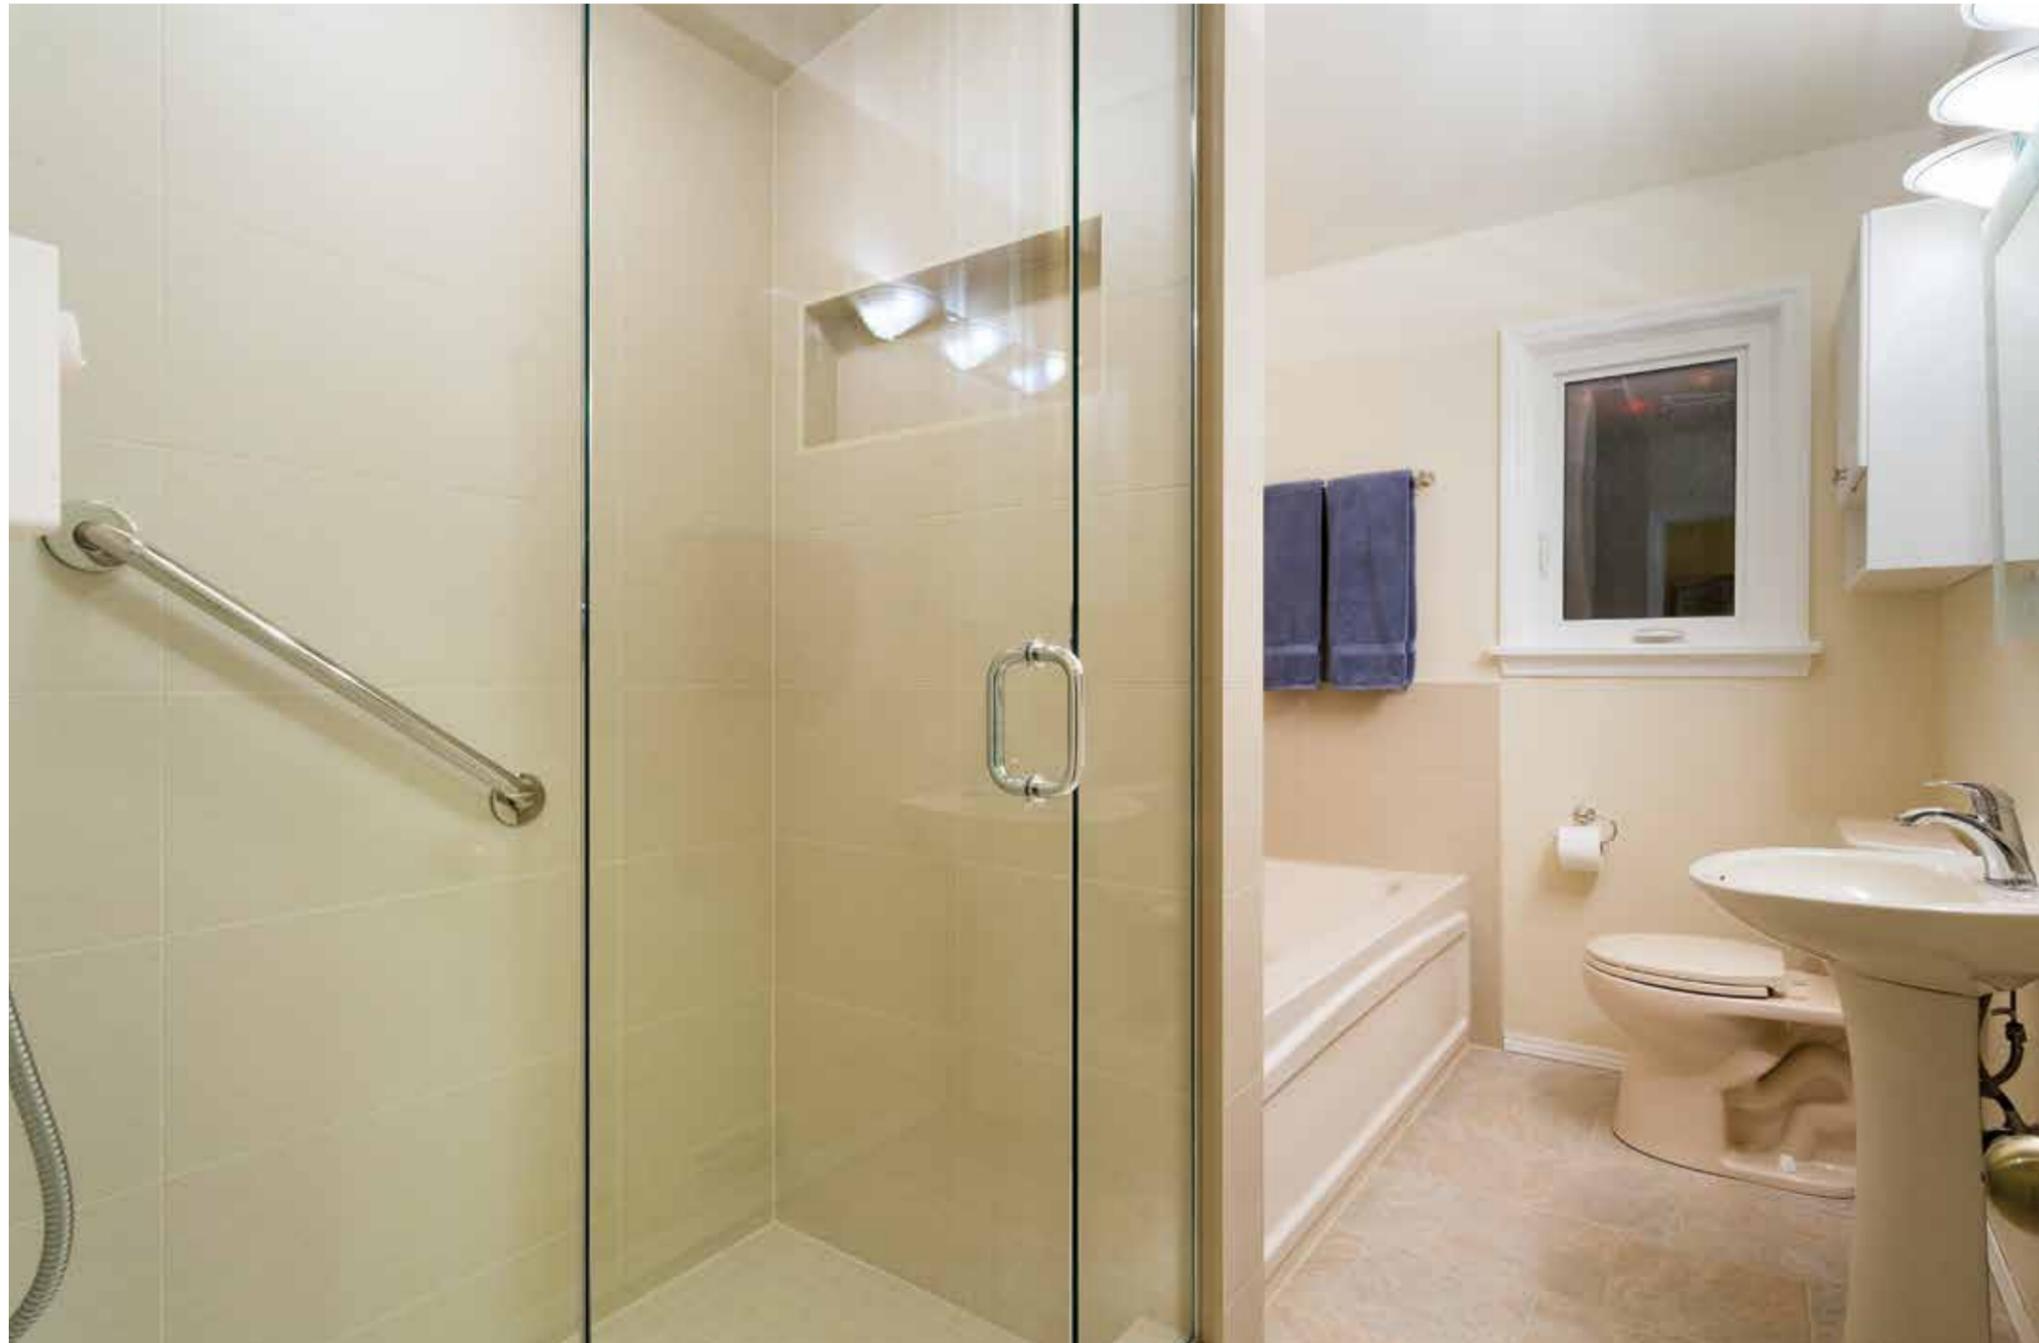
LEFT
A lesser known but important requirement that was missing in the original shower was the use of movement joints in the shower stall.

A lesser known but important requirement that was missing in the original shower was the use of movement joints in the shower stall. "We used Schluter DILEX, which is a prefabricated joint installed on all changes in plane, including floor/wall, wall/wall and wall/ceiling transitions," says Sandra. "These are

designed to accommodate continuing movement in the structure due to thermal expansion and contraction from the heat. These joints assist in the prevention of tile delamination and cracking caused by this movement. We were also able to select a color in this material that matched the grout and tile color so perfectly you don't even realize they are there."

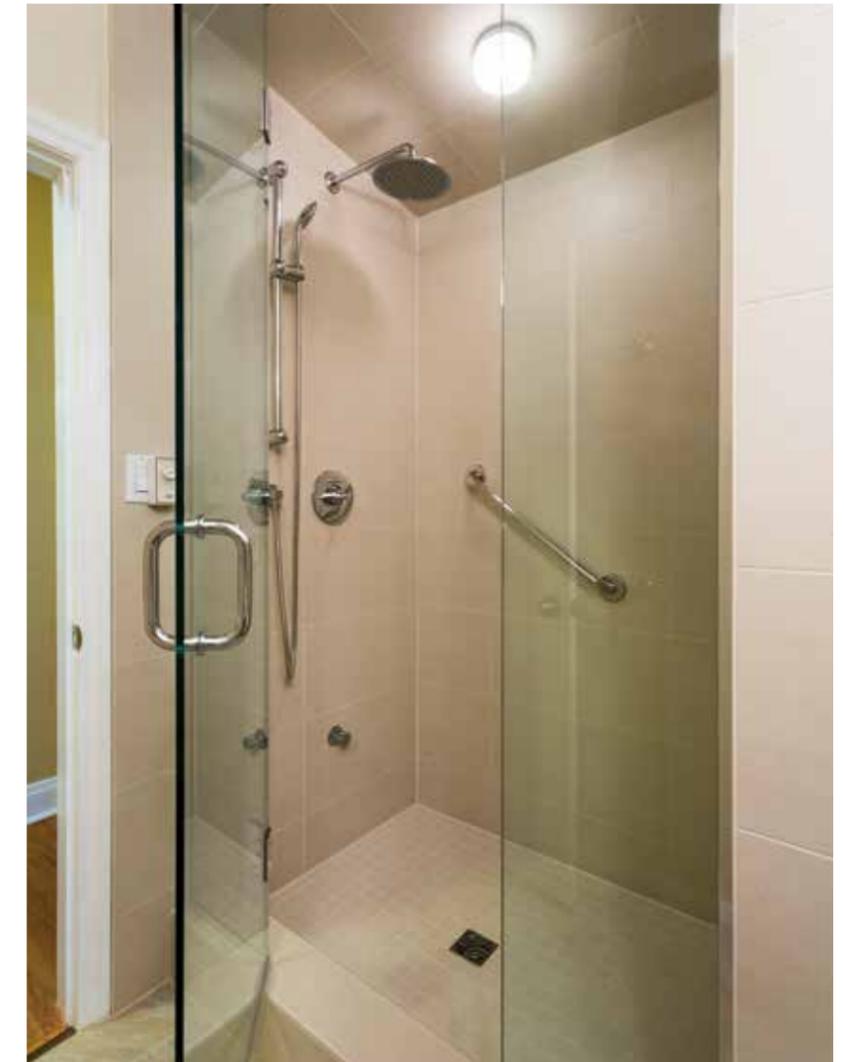
RIGHT
"Aesthetics are extremely important aspects of tiling for us at Torino Tile," says Sandra. "As the poor layout of the tile was Marilyn's initial concern with the previous install, it was essential to have an overall symmetrical look with no awkward placements or small cuts."

"Aesthetics are extremely important aspects of tiling for us at Torino Tile," says Sandra. "As the poor layout of the tile was Marilyn's initial concern with the previous install, it was essential to have an overall symmetrical look with no awkward placements or small cuts." The tiles were installed using a premium Ardex X77 mortar and maintenance-free Ardex Epoxy Grouts ensuring the customers years of maintenance-free use and durability.

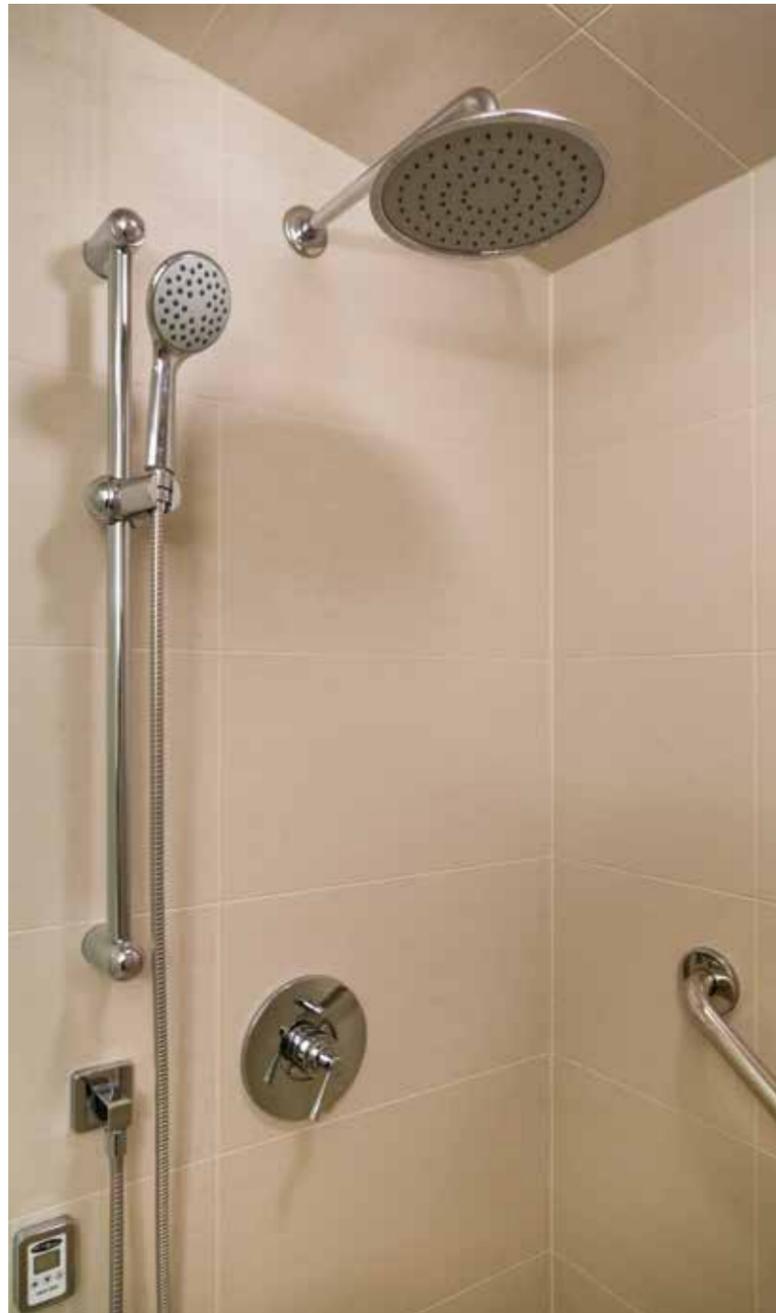
TOP

The shower interior was brought up to speed with quality 12" x 24" full body porcelain tiles in 'Regal Taupe' on both walls and ceiling along with a matching 2" x 2" shower floor tiles.

The shower interior was brought up to speed with quality 12" x 24" full body porcelain tiles in 'Regal Taupe' on both walls and ceiling along with a matching 2" x 2" shower floor tiles. "The installation was done in a contemporary 'grid pattern' which required a dedication of time to design the perfect layout," says Sandra. "Our design team wanted to ensure that the pattern flowed with all the adjoining walls in both the tub area and shower including the ceiling."

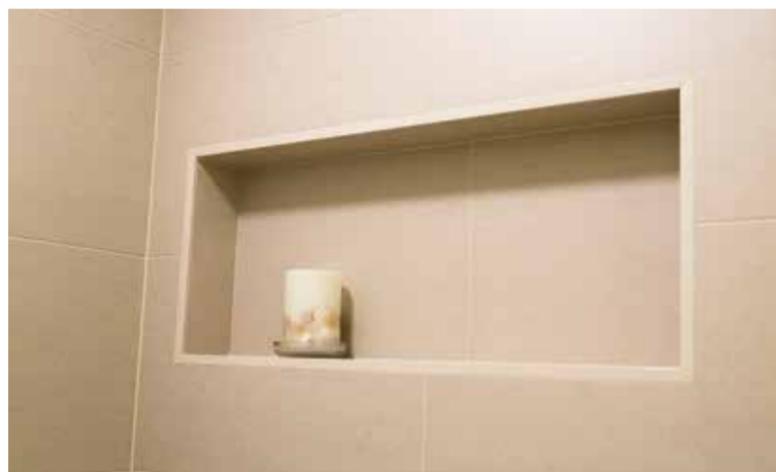
BOTTOM

Sandra explained, "Steam showers are enclosed and constantly filled with vapor. The use of vapour retardants and waterproof materials are critical.

The solution was to install the integrated Schluter® Shower System to ensure complete waterproof integrity. Torino Tile's owner Wayne and master installer Brennan, who both hold Schluter System Certification, used Schluter's KERDI-BOARD for the walls and ceiling and KERDI-SHOWER-ST pre-sloped tray for the floor. All seams were sealed with Schluter KERDI-BAND and KERDI-SEALS and KERDI-FIX was used around all fixtures to prevent vapour penetration. The installation of a lighting fixture specified for the use in a steam shower was also installed.
